4.1 GENERAL DESIGN CONSIDERATIONS

This chapter discusses structural, building envelope, and nonstructural building systems, and illustrates various types of wind-induced damage that affect them. It also presents six case studies. Numerous examples of best practices pertaining to new and existing hospitals are presented as recommended design guidelines. Incorporating those practices applicable to specific projects will result in greater wind-resistance reliability and will, therefore, decrease expenditures for repair of wind-damaged facilities, provide enhanced protection for occupants, and avoid disruption of critical services.

The recommendations presented in this manual are based on field observation research conducted on 25 hospitals that were struck by

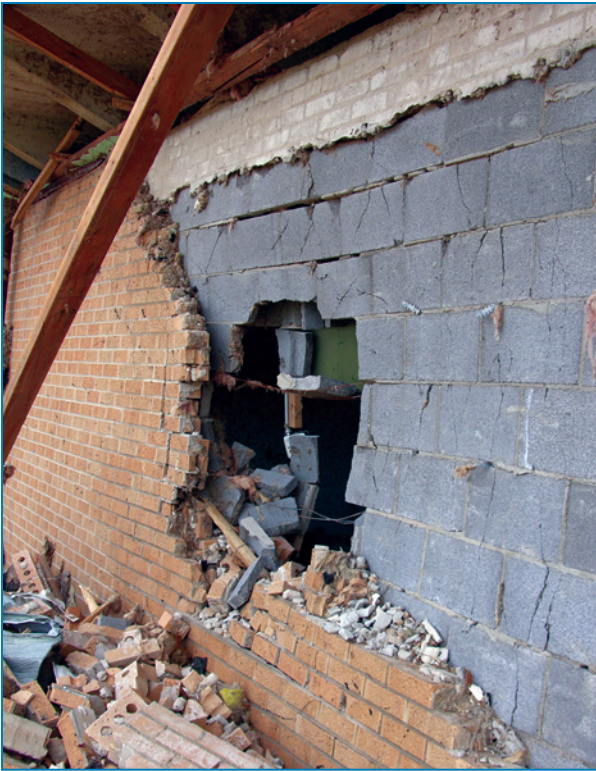
Figure 4-137:

A missile impact created an opening in the brick veneer and unreinforced CMU.

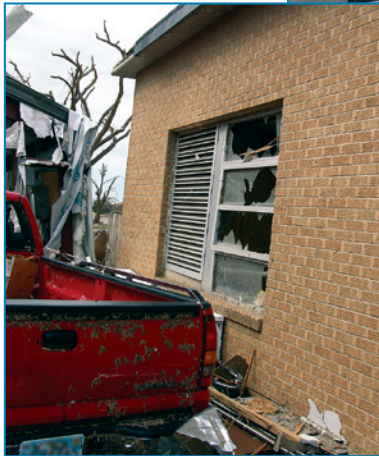
Figure 4-138:

The building shown in Figure 4-131 (yellow arrow) and in Figure 4-138 housed the emergency generator. The sectional door collapsed and allowed wind-borne debris to strike the generator. All window panes in the wall adjacent to the sectional door were broken (see inset at Figure 4-138). The wall louver adjacent to the window, which served the generator room, escaped damage.

The sectional door (red arrow) at the generator building was blown in and windows were broken by debris.

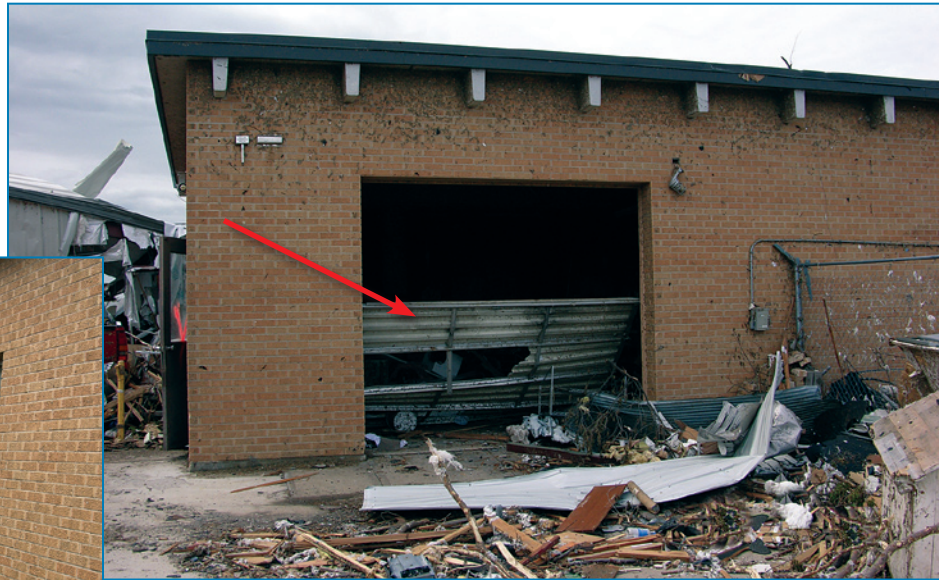
Figure 4-139:

There was no apparent structural damage to the 1965 addition. However, the unreinforced brick/CMU parapet shown in Figure 4-139 fell onto the roof, rather than in the other direction, where it would have blocked the entry and possibly could have caused injuries. Virtually all of the exterior windows were broken (see Figures 4-135 and 4-136). The roof insulation and aggregate-ballasted single-ply roof membrane were blown off. The wood roof structure blew off the majority of the 1982 addition (Figures 4-133 and 4-140), and virtually all of the exterior windows were broken.

Collapsed unreinforced masonry parapet. Note the broken windows.

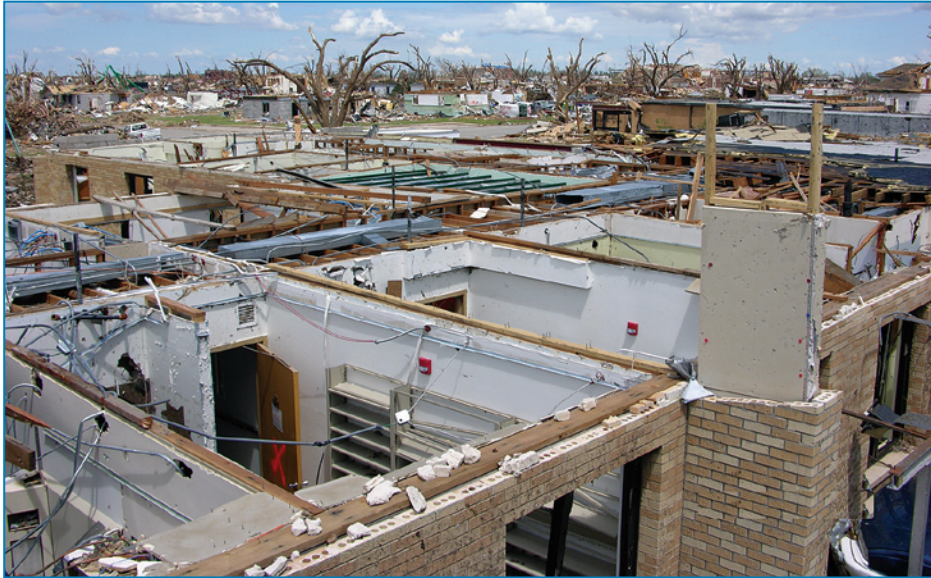
Figure 4-140:
Loss of the wood
roof structure at the
1982 addition.

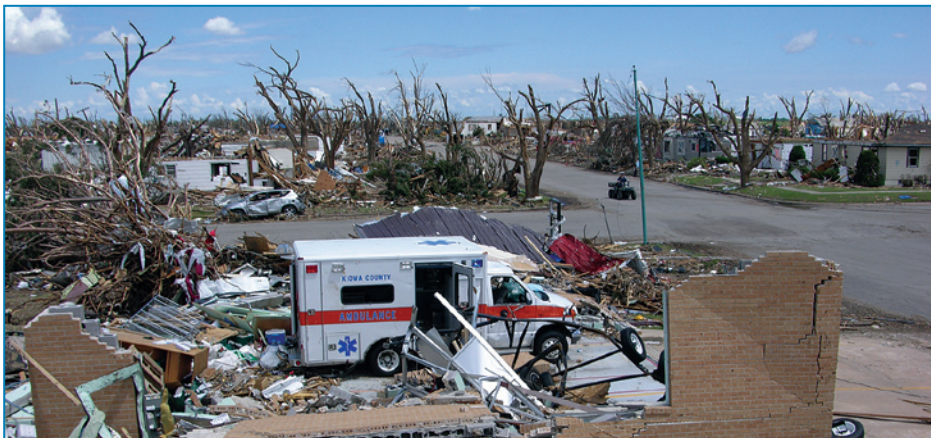
The precast twin-tees on the ambulance garage blew off and landed against the wall of the 1982 addition (Figures 4-133 and inset at 4-141). The garage door and virtually all of the exterior unreinforced brick/CMU bearing walls collapsed (Figure 4-141). Where the tees rested on the bearing wall, steel bearing plates were embedded in the tee's beams. However, bearing plates had not been embedded on top of the support walls. Rather, where

Figure 4-141:
View of the collapsed
ambulance garage.
The twin-tees (red
arrows) flew to the left,
as shown in the inset.

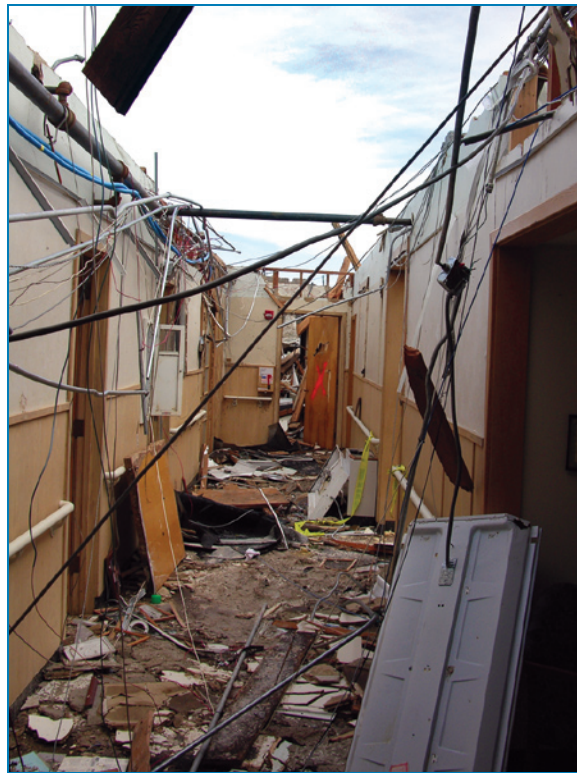
The loss of life and avoidance of injuries was attributed to three factors. 1) A tornado warning was issued by the National Weather Service about 20 minutes before the tornado struck, and the hospital's staff was aware of the warning. 2) The hospital had a tornado evacuation plan and there was sufficient time to execute the plan. 3) Although it is believed that the basement was not specifically designed as a tornado shelter, it provided a safe area of refuge for patients and staff. For hospitals located in tornado-prone regions, the experience from this tornado demonstrates the importance of having a pre-identified, best available refuge area (or preferably a FEMA 361-compliant shelter). Although small interior rooms and corridors sometimes provide adequate protection during tornadoes, unless specifically designed as a tornado shelter, they often provide inadequate protection, as shown in Figure 4-142.

Figure 4-142:
View of a main
corridor in the 1982
addition

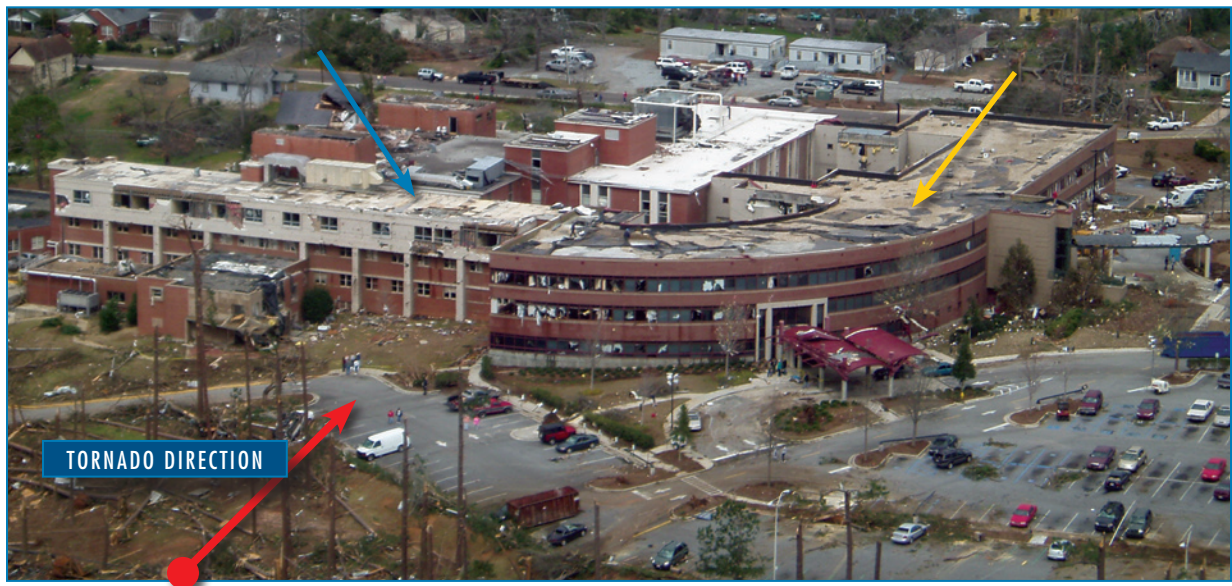
Figure 4-143:

Aerial view of the facility after it was struck by the tornado. The red arrow indicates the general direction of the tornado. The blue arrow shows the 1953 building, and the yellow arrow shows the 1999 building. The 1975 and 1983 additions are adjacent to and behind the 1953 and 1999 buildings.

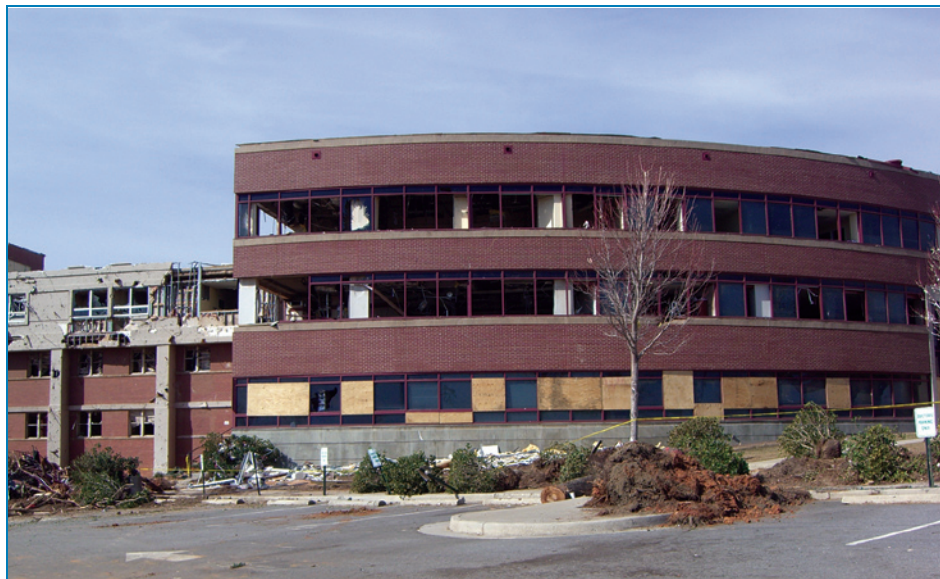
Figure 4-144:

As the tornado approached the southwest side of the hospital, numerous tree branches from trees in front of the hospital were thrown against the building. Missiles broke virtually all of the glass in the southwest walls (Figures 4-144 and 4-145), and missiles penetrated the EIFS and landed inside the building. Roof decking and steel joists were blown off of portions of the 1953 building, and the roof membrane was blown off of several different areas of the facility.

The 1999 addition is on the right, and the 1953 building is to the left. Virtually all of the glass on these facades was broken.

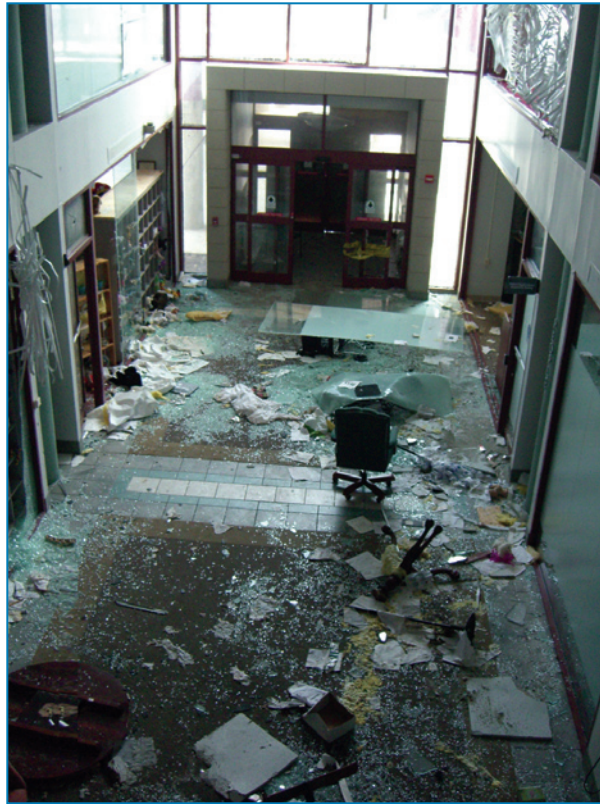
Broken glass showered the rooms along the exterior walls. The breach of the building envelope allowed strong winds to enter the rooms and corridors, which led to the collapse of suspended acoustical ceilings and light fixtures. Figure 4-147 illustrates the extent of the interior damage.

Figure 4-147:
Glass shards and
other debris in the
lobby area housing
retail shops and
offices.
